Manhole Inspection Summary

Manhole # S69Q__006MH

Insp Date: **1/28/08 8:49 AM**

Location Address: **1412 Dundalk Ave.**

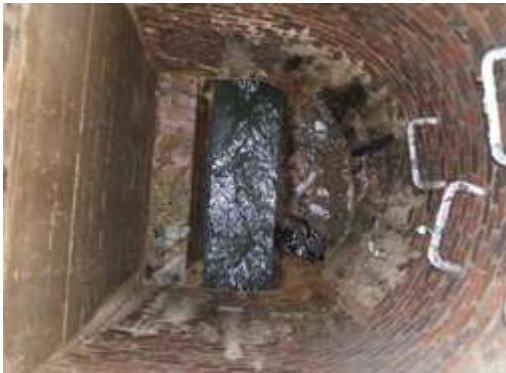
Top View

Comments **INTERCEPTOR. 4 O'CLOCK IN BLOCKED UP SEVERELY.**

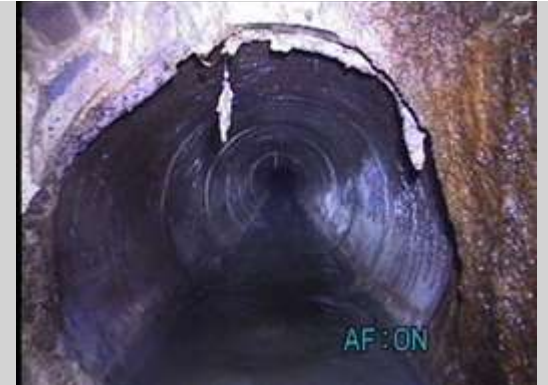
12 O'Clock Outflow

24 in. Circular Gravity Sewer
Pipe Out @ 12 O'Clock

Pipe Height: **24** (in.) Rod and Bar (Angled)
Pipe Material: **Clay** ☐ Pipe Lined
Invert Depth: **14.13** (ft.) Flow Characteristics: **Fast**
Deposits: ☒ None ☐ Mud ☐ Sludge ☐ Debris ☐ Grease
Silt Depth: (in.) Deposits Extent:
Infiltration: **None** Pipe Seal Cond: **Sound**

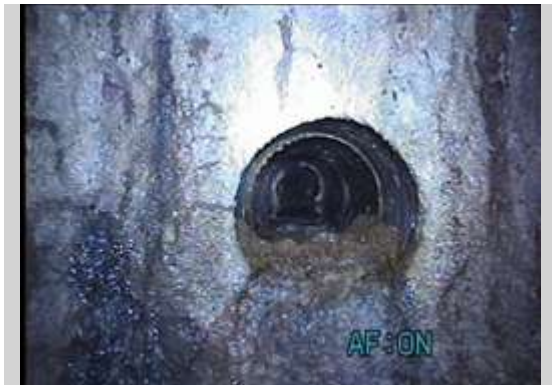
4 O'Clock Inflow

8 in. Circular Gravity Sewer
Pipe In @ 4 O'Clock

Pipe Height: **8.4** (in.) Rod and Bar (Angled)
Pipe Material: **Clay** ☐ Pipe Lined
Invert Depth: **10.46** (ft.) Flow Characteristics: **Slow**
Deposits: ☐ None ☐ Mud ☒ Sludge ☒ Debris ☐ Grease
Silt Depth: **2** (in.) Deposits Extent: **Heavy**
Infiltration: **None** Pipe Seal Cond: **Sound**

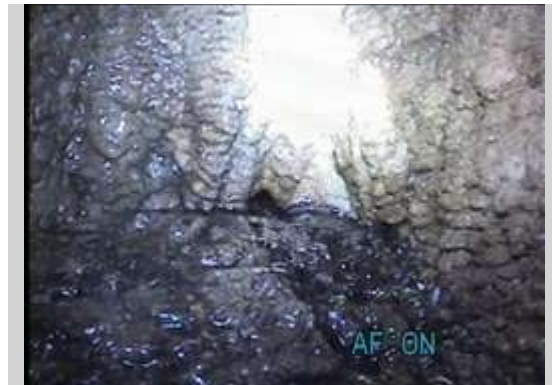
Drop In @ 4 O'Clock

Drop: **Outside** Rod and Bar
Angled: **Yes** Reading: **12.00** (ft.)
Inv Depth: **13.00** (ft.)
Drop Condition: **Clogged**

Connects To: **Dead End**

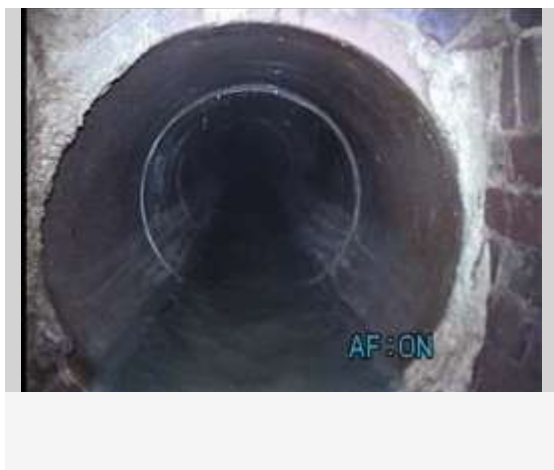
6 O'Clock Inflow

24 in. Circular Gravity Sewer
Pipe In @ 6 O'Clock

Infiltration: **None** Pipe Seal Cond: **Sound**
